PROJECT SPOTLIGHT:
GLENRIDGE HALL,
SANDY SPRINGS, GA
THE R.W. STOKES COMPANY

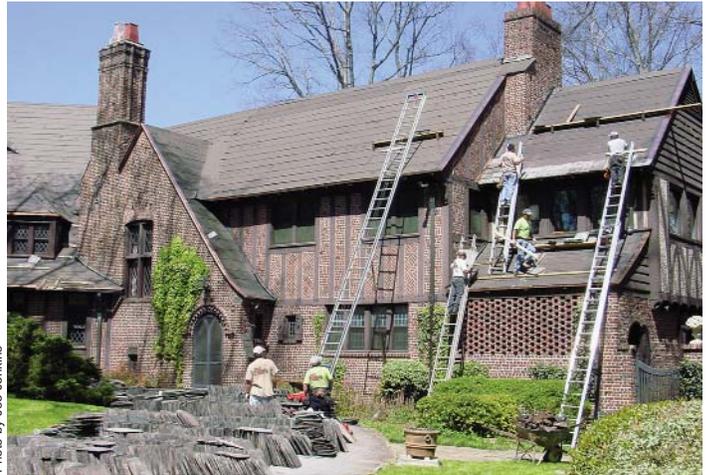
Photo by Joe Jenkins

Glenridge Hall, front entrance, after the original slate had been removed and stacked in the driveway and the new felt installed. Re-slating is just beginning.

Ron Stokes' crew foreman for this project was Manuel Avila whose crew had to remove all of the slate on the entire Hall, salvage it as best they could, then re-install it back on the same building with proper headlap over half-lapped 30 pound felt. The salvaged slates were used on the front of the Hall first, in order to preserve the historical look of the building. The front, however, consumed just about all of the salvaged slates.

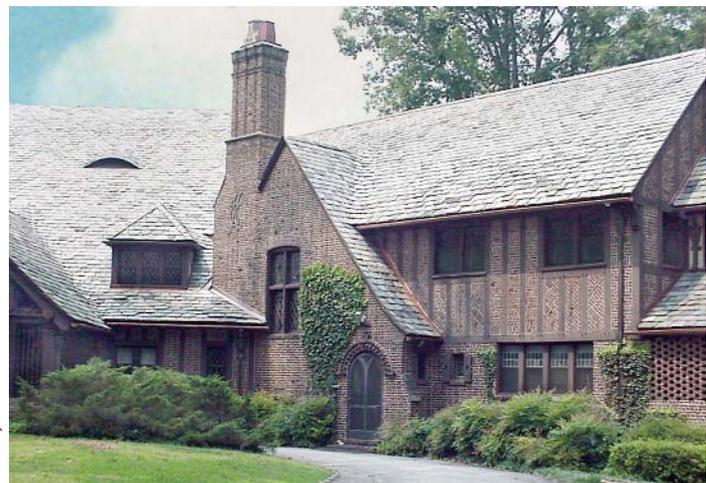
Photo by Ron Stokes

Glenridge Hall. The finished roof is not only beautiful, but also historically accurate. It can realistically last another century.

New slates of the same color mix and graduation scheme were installed on the back of the building, supplied by Steve Yoder of Classic Slate and Tile in Atlanta. The rounded valleys and eyebrow dormers were fortified by 20 ounce copper flashing applied underneath each course of slates in the curved sections. All of the remaining flashings on the roof were replaced during the re-installation, again using 20 ounce copper. This was a long, arduous project delayed by a lot of rainy weather, but The R.W. Stokes Company managed to complete it in the summer of 2003.
