HURRICANE FORCE WINDS

AND HOW THEY AFFECT SLATE ROOFS

Joseph Jenkins

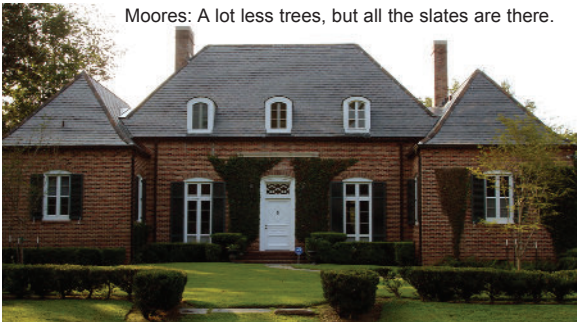
The roof damage was nonexistent. That's right — there was no damage to the roof by the hurricane. Not a single slate blew off. As a roof consultant, I had thoroughly inspected

Moores: A lot less trees, but all the slates are there.

the roof the year before the hurricane. My visit after the hurricane confirmed what seems improbable — no damage to the roof. Installed in 2003, the 50 square roof was made of standard-thickness Vermont gray-black slates, 10" wide and 16" long, from Camara and Sons Slate Company. It was installed on approximately a 12:12 slope, with 11 gauge copper, smooth-shank 1.5" slating nails over a traditional board deck.

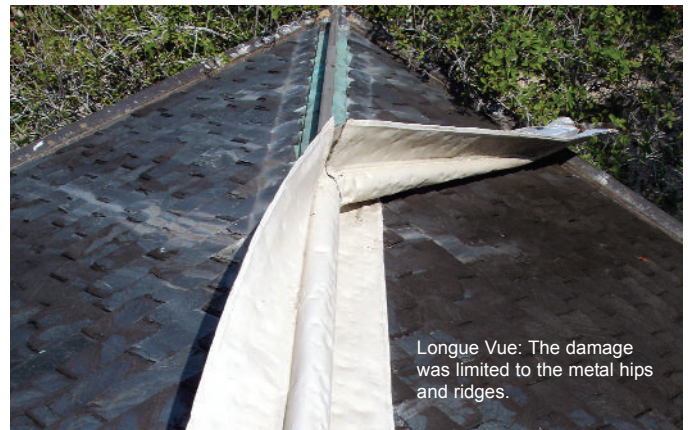
Longue Vue: The damage was limited to the metal hips and ridges.

1942, the roof is made of 14" long, random-width Buckingham slates, 1/4" to 3/4" thick, with a 4" headlap, nailed to a standard board roof deck on approximately a 7:12 slope with smooth-shank copper slating nails. Although there was virtually no damage to the slates themselves, many of the lead-coated copper ridge and hip coverings blew loose. All of the damage was repairable.

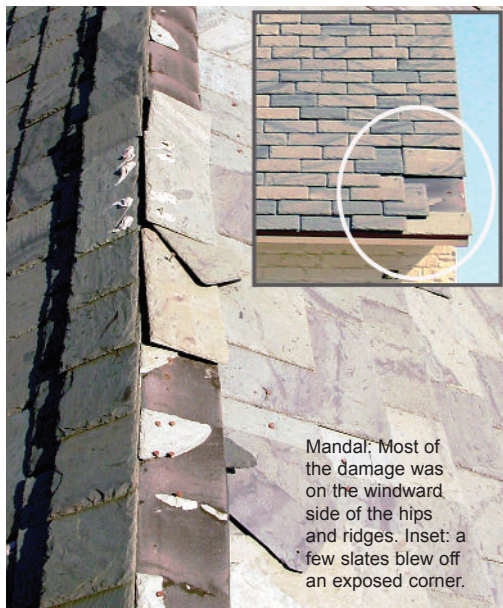
The 136 square Mandal roof, installed in 2004, had a slope ranging from 7:12 to 10:12. It was made of 18" random-width, standard-thickness, unfading gray slate from Evergreen Slate Company, with a 4" headlap, 2" copper smooth-shank slating nails, on a 3/4" plywood deck. It did suffer some damage. The main damage was slates that blew off the saddle hips and ridges, mainly on the windward side. The 7"x14" ridge and hip slates had been nailed with 2" nails also. This roof would have benefitted from 1.5" nails in the field because the 2" nails were too long and broke out the back of the roof decking, effectively diminishing the holding power of the nails (see Figure 2, page 19). The hip and ridge slates, on the other hand, would have benefitted from a more typical 2.5" nail, rather than a 2" nail. There was also some damage in the field of the roof from flying debris. Some slates along some windward edges also blew off. In total, about 250 of the 21,000 slates blew off — about 1.19%, a phenomenally small amount of damage after such a massive assault.

Mandal: Most of the damage was on the windward side of the hips and ridges. Inset: a few slates blew off an exposed corner.

It seems that there are four things we can do to maximize wind resistance on a slate roof: 1) Use more headlap rather than less. Four inch headlap in a high-wind area is recommended. 2) Use the correct length nail. A nail that's too short or too long can reduce the effective holding power of the nail. Smooth shank slating nails apparently have adequate holding power. 3) Use a solid wood roof deck, at least 3/4" thick. 4) Use adequate slope. A slate roof would ideally be too steep to walk on.
